Correct CV Boot Band Tension

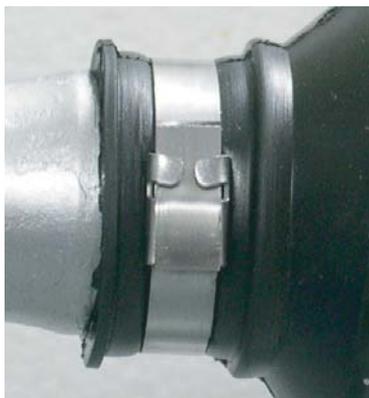
Pic A

A correctly tensioned clamp should be tightened until the CV Boot is just starting to be squashed out a little from either side of the clamp. The finished clamp should sit slightly below the height of the CV Boot rubber.

CORRECT TENSION

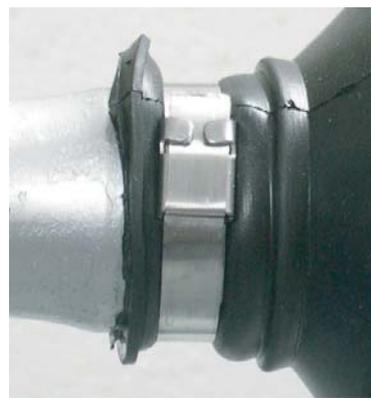
An over tightened CV Clamp squashes the CV Boot well beyond an acceptable limit. It causes a considerable amount of rubber to be squashed out from beneath the clamp and under extreme circumstances can cause the boot on either side of the clamp to curl up and around the clamp. An over tightened clamp can also cut the boot, if not straight away it is likely it will cut into the boot within a short period of time once in operation. Due to the boot being under such stress and compression it is unable to flex as it would under the correct tension, due to this inability to flex the boot will tear or split on or near the edge of the CV clamp within a short period of time. Refer Pic. B

INCORRECT TENSION
