CV Boot Maintenance Fact

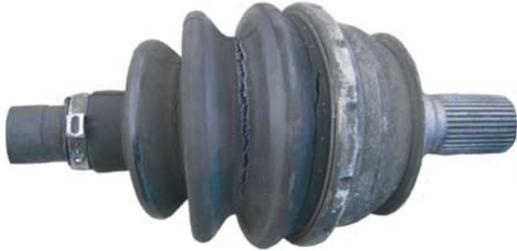
Don't let this.....

Cracked or Perished Boot

CV boots deteriorate over time and require replacement prior to failure. The most common cause of CV joint failure is from the deterioration and splitting or tearing of the rubber CV Boot. This allows the protective grease to escape and dirt, road grime and water to enter into the CV joint. This causes the CV joint to wear rapidly and fail prematurely. As long as a CV Joint remains sealed and protected by the CV boot, no harm will come its way. It will do its job until it wears out normally.

Replacing your CV boots before they fail is a good example of how money spent on maintenance can prevent more expensive repairs in the future. CV boots should be replaced as soon as any cracks, splits, leaks or tears are noticed by your mechanic. CV Boots are inspected with every regular service of your vehicle. Your Mechanic will spot a worn CV Boot and recommend replacing the boot before any serious harm can be done to your CV joint. Replacing your CV boots at the first sign of wear or damage can prevent the more costly exercise of replacing your entire drive shaft a few months later.

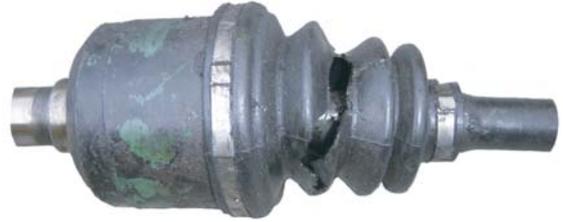
....turn into this!

Split Boot & Damaged Joint
